*Urszula Kraśniewska*

Wrocław University of Science and Technology

RESTORATION WORK IN THE MAIN  
SANCTUARY OF AMUN  
OF THE TEMPLE OF HATSHEPSUT  
IN DEIR EL-BAHARI

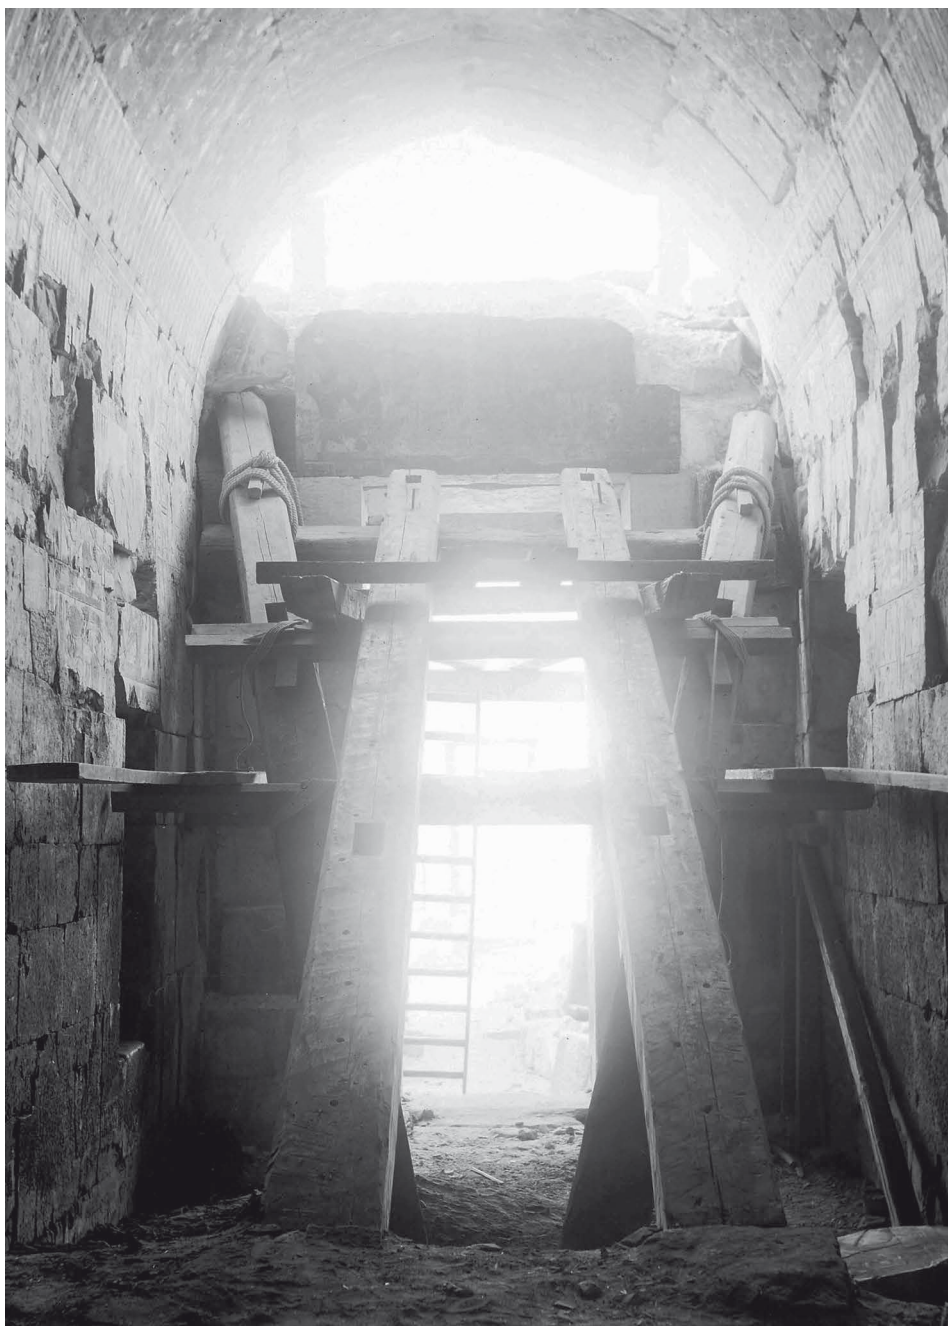
Pl. 4 – Strengthening and repairing the eastern wall of the Barge Hall.  
Photo archives of The Egypt Exploration Society

The sixth volume of *The Temple of Deir el-Bahari* contains an architectural study by Somers Clarke, an architect cooperating with Neville. Clarke describes the dislocations which took place in the Sanctuary walls, mentioning that the northern wall of the Barge Hall was seriously damaged. He analyzes the structure of the Sanctuary and describes the condition of the walls and the structure of vaulting in the first room. He also specifies antique reconstructions and repairs which were performed here. He mentions the repair which took place in the portal of the western wall of the Barge Hall, done by the Egypt Exploration Fund. The lintel fell and descended almost to the floor; in 1896, it was installed again in the proper place, along with reconstruction of the southern frame of the portal. Repairs and reinforcement of the eastern wall were also done in the Barge Hall (Pl. 4). Clarke describes the Sanctuary vaults as apparent, and describes the load-relief system, which emerges over the stone leaning (Neville 1908, 25-29). The activity of the mission led by Eduard Neville finished in 1899. It was the first restoration undertaken on such a large scale at Hatshepsut Temple, but the Sanctuary itself did not receive more significant repairs.

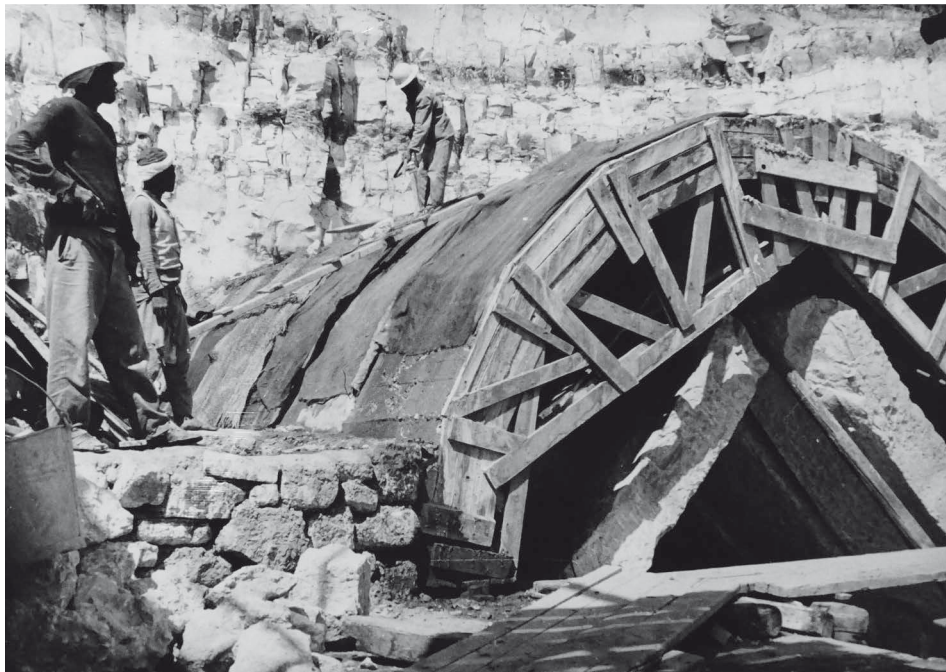
Pl. 6 – Concreting the reinforced concrete vault over the antique construction relieving the vault of the Sanctuary. Courtesy of PCMA UW

In November 1974, works on the reconstruction of the central part of stone platform were initiated, including the reinforced concrete dome protecting the original vaulting of the Sanctuary. When both wall wings were already nearly finished, before the completion of the works it was necessary to work on the triangular load-relief system. Special mobile scaffoldings were prepared, which made it possible to concrete the dome fragment by fragment, respecting the width of 120cm. The dome itself is 30cm thick, reinforced with a double mesh of steel bars with a thickness of 12mm. Performing this scope of works made it possible to continue the works involving the connection of a rock platform, which was planned for the subsequent season (Wysocki 1975, 1, 5) (Pl. 6).

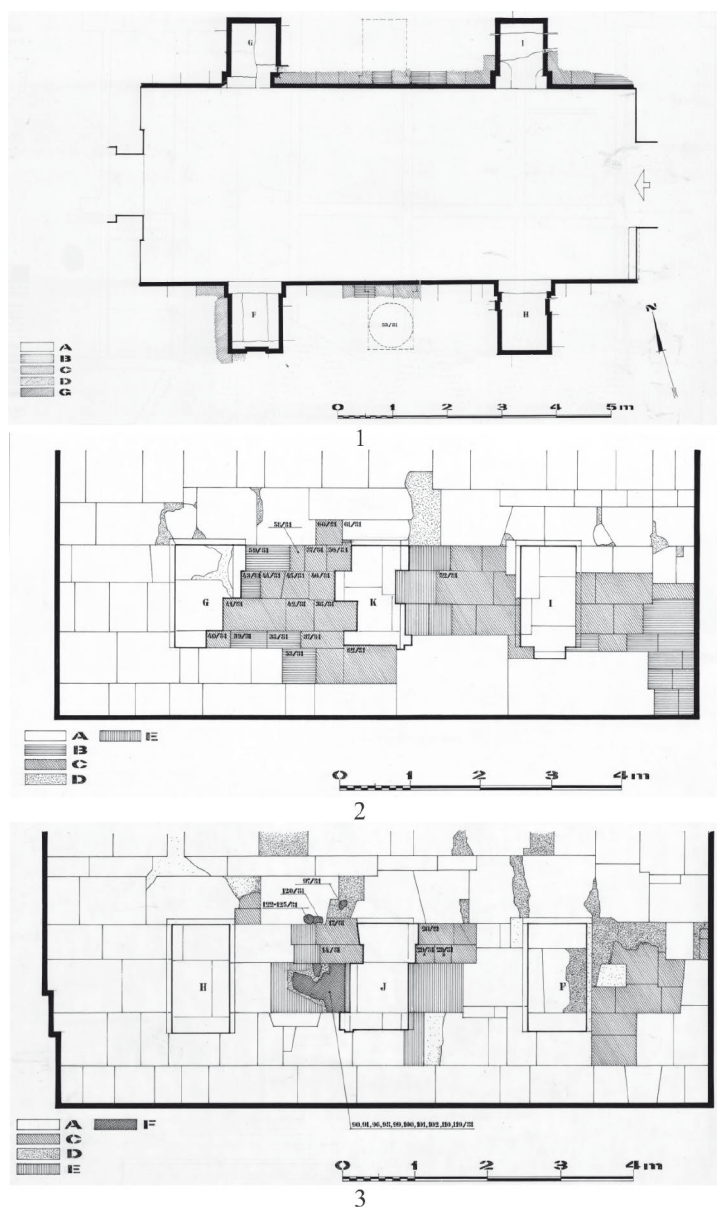
Pl. 7. 1 – A horizontal view of the first chamber of the Main Sanctuary. The state before the 1980/81 season. Courtesy of PCMA UW

Pl. 7. 2 – A view of the north wall of the first chamber of the Main Sanctuary. The state after completing the studies and the preservation and reintegration work of the newly discovered niche 'K' in the 1981/82 season. Courtesy of PCMA UW

Pl. 7. 3 – A view of the south wall of the first chamber of the Main Sanctuary. The state after completing the studies and the preservation and reintegration work of the newly discovered niche 'P' in the 1981/82 season. Courtesy of PCMA UW

In the 1980-81 season, the architect Adam Stefanowicz conducted a series of studies and outcrops of the northern and southern walls of the Barge Hall. In 1981, Zygmunt Wysocki studied the layers of blocks and joints, and then he discovered on the face of both rebuilt walls traces suggesting there may have been internal niches on each of them, which were most probably covered in the Ptolemaic period. Due to a number of vertical cracks, it was decided to conduct deconstruction works in a limited scope in order to confirm the thesis. Before beginning the works, measurement, drawing and photographic inventory were performed, and then the removal of stone blocks began in the southern and northern walls, giving each of the discovered elements a number (Pl. 7: 1-3). The team of archaeologists led by Janusz Karkowski studied the composition of the obtained material filling both niches. The good condition of the northern niche made it possible to uncover it completely (Pl. 8). After the uncovering of both niches, according to their condition, documentation was done in the same way as before beginning the works (Stefanowicz 1981, 1-4). All of the works were conducted in January 1980, right after Wysocki's discovery. From December 1981 until February 1982, the reconstruction of both niches was in progress. Frame fragments were emptied and restored (Wysocki 1985, 366-368). In the 1982/83 season, Stefanowicz made the inventory of wall surface and joints of the walls next to the granite portal leading to the Barge Hall. Studies included the connection of relief frames of the limestone portal with the longitudinal Sanctuary walls, the course of horizontal joints adjoining in wall corners as well as semicircular gable wall with the Sanctuary's entrance portal. Drawings of this wall were performed, together with

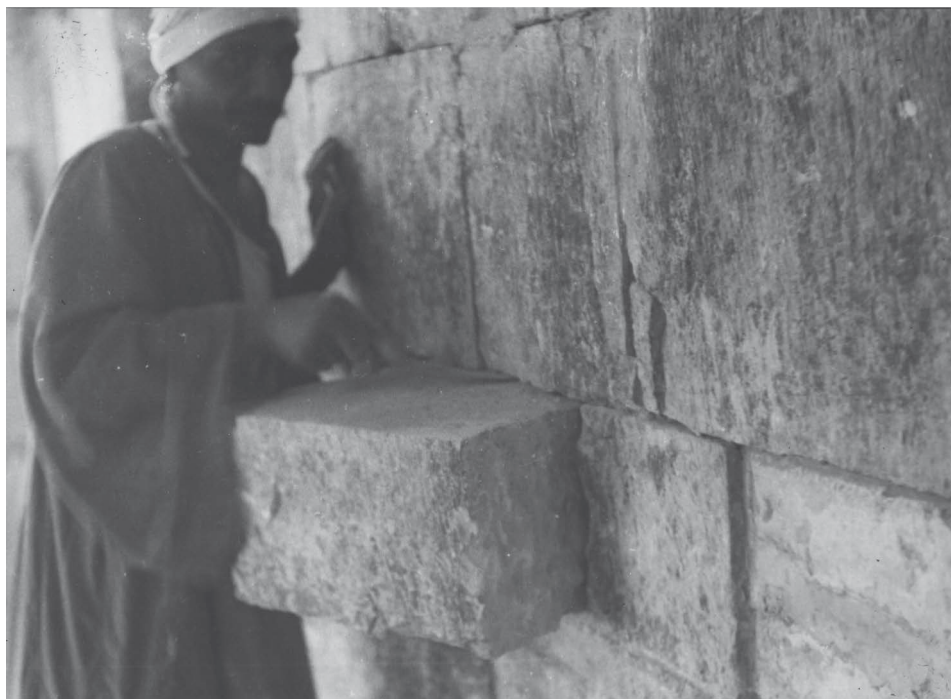
Pl. 8 – Removal of the first stone block no. 1/81 in south wall of Barge Hall.  
Courtesy of PCMA UW
