THE FORTIFICATIONS
OF THE ENTRANCE GATE
IN THE WESTERN DEFENSE WALL
OF WESTERN TANAIS

Abstract: *Since 1999 the Polish Archaeological Expedition has been working in Western Tanais. One of the important structures recovered in Trench XXV is the entrance gate.*

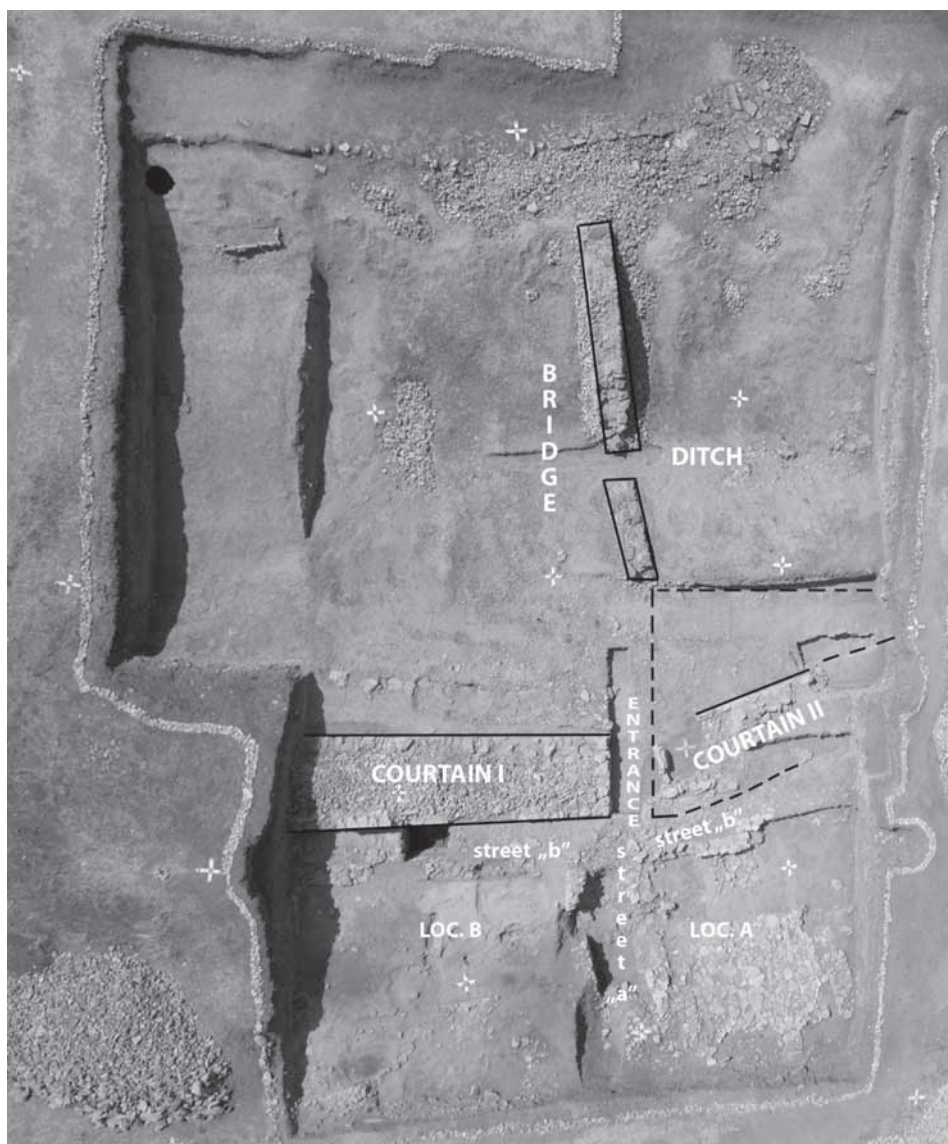
Pl. 2. Trench XXV. Photo by M. Bogacki

In 1999 work was resumed in Western Tanais, this time by a team from the University of Warsaw (the Antiquity of Southeastern Europe Research Centre and the Institute of Archaeology), working until today as part of the Russian Archaeological Expedition directed by T. M. Arsen'eva. Approximately 1000m² of the area of the western town has been uncovered

so far (Trench XXV) (Pl. 2). At least two building phases were identified, the second one being dated to the end of the 2nd and beginning of the 1st century BC. The defences as well as neighbouring dwelling quarters were given a general overhaul, changing in effect the spatial planning of this part of the town (Scholl 2011a). The entrance gate, a major strategic point of any defences, was fortified with particular care (Pl. 3: 1).
