A BYZANTINE CHAPEL IN THE YĀJŪZ REGION OF AMMAN, JORDAN

ABSTRACT: In autumn 2017, the Department of Antiquities undertook a rescue excavation in Areas A and D, located at the northern periphery of the Yājūz district within the Shafā Badrān region, north of Amman. The excavation aimed to elucidate the nature of architectural remains partially exposed above the surface, with the objective of characterising the site and its settlement dynamics. Special emphasis was placed on an ecclesiastical monument discovered during the fieldwork. The study entailed a detailed analysis of the chapel's architectural plan, the surrounding residential structures, their architectural elements and associated material culture. Comparative assessments were conducted with analogous chapels within Yājūz, focusing on similarities in spatial organisation, construction materials and mosaic decoration. These results were situated within the broader historical context of Christian communities in the region during the Byzantine era and the subsequent transition to Islamic governance. Chronological attribution of the chapel's construction was inferred from its architectural features and material assemblages, with

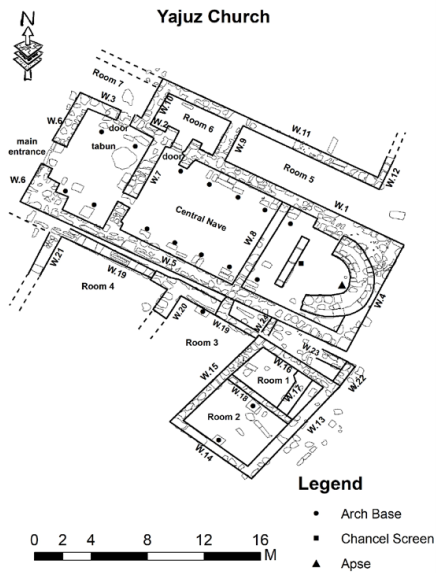
Pl. 1: 1 – Map showing the location of Yājūz
Pl. 1: 2 – Layout of the church and residential dwellings to the south (by Hashem Khries)

ern service chambers (Rooms 5-7) (see Pl. 1: 2, 2: 1). The sanctuary comprises a semicircular apse, a chancel and a chancel screen that separates the apse from the nave. Within the apse, four ascending tiers – presumably constituting a synthronon for the presbyters – are present (Pl. 2: 2, 3: 1). No evidence of plaster coating was identified on the internal walls of the apse. The tiers are primarily constructed from well-dressed stone blocks, although certain sections along the southern side use rubble masonry.

The chancel screen – of which only four well-cut limestone blocks of varying sizes remain *in situ* as foundational elements – measures approximately 3.80 m (north-south) by 0.50 m (east-west) (see Pl. 1: 2, 2: 1). No evidence of an altar was identified within the chancel area, despite its customary placement immediately west of the apse chord in Byzantine churches. Similarly, grooves and postholes that would have supported a balustrade enclosing the altar – features commonly present at the western end of the chancel in Byzantine churches throughout Jordan – are notably absent. This absence may be attributed to the intentional removal of these elements during a subsequent phase of church reuse in the Umayyad period. Supporting this interpretation is the presence of a wall (Wall 8), likely dating to the Umayyad period, constructed directly west of the former chancel screen. Wall 8 extends approximately 6.35 m along the north-south axis, has a preserved height of 0.95 m and is built directly on the bedrock (see Pl. 3: 1).

The narthex leads into the central nave through a doorway measuring 1 m in width, situated in their shared boundary, identified as Wall 7 (see Pl. 1: 2). The central nave provides access to Room 6, which measures 4.20 × 2.60 m, via a doorway 0.80 m wide located centrally within the common wall. A threshold constructed from well-cut limestone is positioned at the entrance. The floor level of Room 6 is elevated approximately 0.24 m above that of the central nave, aligning it closely with the level of the presbytery. The walls of Room 6 preserve remnants of a plaster layer, while its floor is finely paved with large mosaic cubes. Although some sections of the mosaic pavement remain intact, particularly adjacent to the northern wall (Wall 11), a small preserved patch depicts a bird with a four-feathered tail enclosed within a circular band measuring 0.45 m in diameter. This image is rendered in small mosaic tesserae in hues of yellow, burgundy, white and black (Pl. 4: 2). The bird is flanked on three sides by three grape leaves composed of red cubes: two positioned near the legs and one above the back. Each leaf consists of four branches or lobes intersecting centrally to form a cross-like pattern.

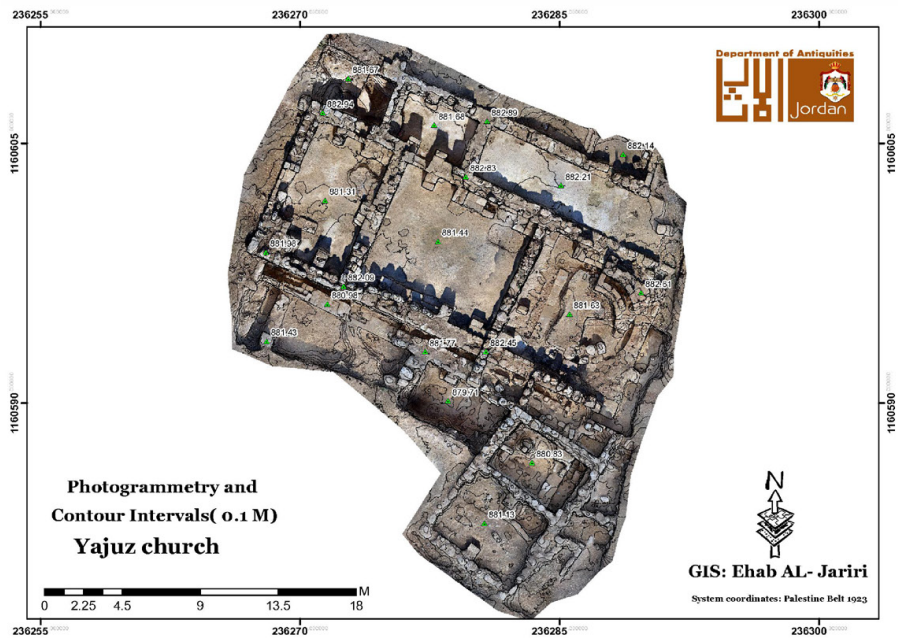
Pl. 2: 1 – Layout of the church and residential dwellings to the south with the material of construction (by DoA)
Pl. 2: 2 – General view of the chapel of Yājūz, looking west (by Taher al-Gonmeen)

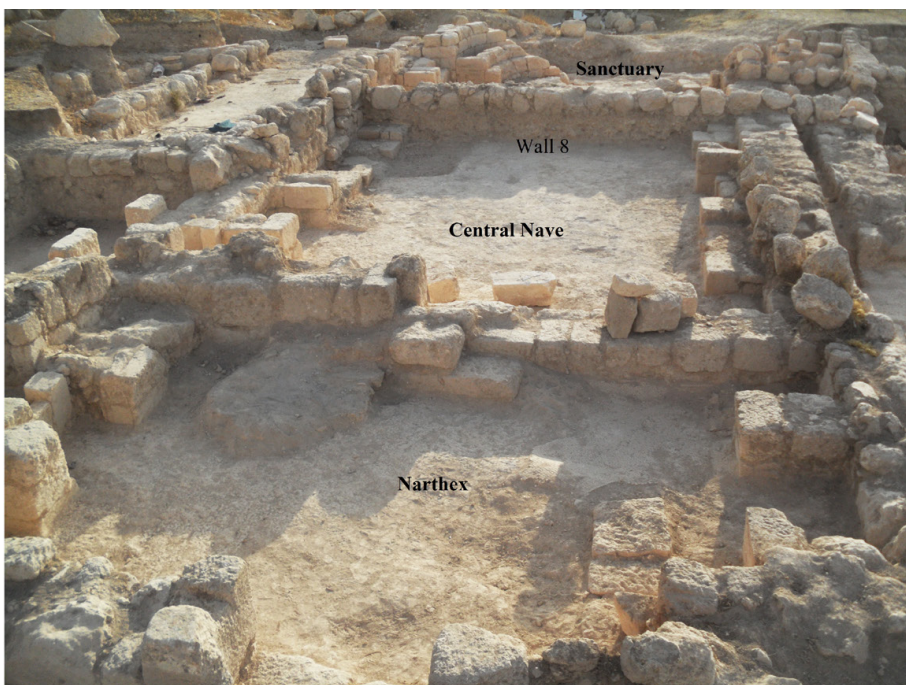
Pl. 3: 1 – The narthex and central nave of the chapel of Yājūz (by Taher al-Gonmeen)

The central nave measures approximately 10 m in length, extending from the eastern wall of the narthex (Wall 7) to the chancel screen, and spans roughly 6.40 m along the north-south axis (see Pl. 3: 1). Along both the northern and southern walls of the nave, five arch bases were identified, originally intended to support a barrel-vaulted roof (see Pl. 3: 1). These bases are constructed from well-dressed limestone blocks and are positioned at irregular intervals ranging from 1.75 and 1.90 m. All ten arch bases were found *in situ* and are composed of blocks measuring approximately 0.70×0.80 m, with preserved heights varying from 0.45 to 0.85 m above the bedrock surface.

Two arch bases, placed at regular intervals approximately 2 m apart, were identified along the northern and southern walls of the narthex and were likely intended to support a barrel-vaulted ceiling (see Pl. 3: 1). Of particular note is the presence of an irregularly shaped clay tabun, approximately 1.40 m in diameter, situated adjacent to the eastern wall of the narthex (Wall 7). The surrounding area contained significant concentrations of ash and charcoal. Moreover, ceramic evidence – including fragments of a cooking pot and two jugs – was found *in situ* near Wall 3, close to the doorway connecting the narthex to Room 7. These finds are dated to the Late Byzantine/Early Umayyad period.

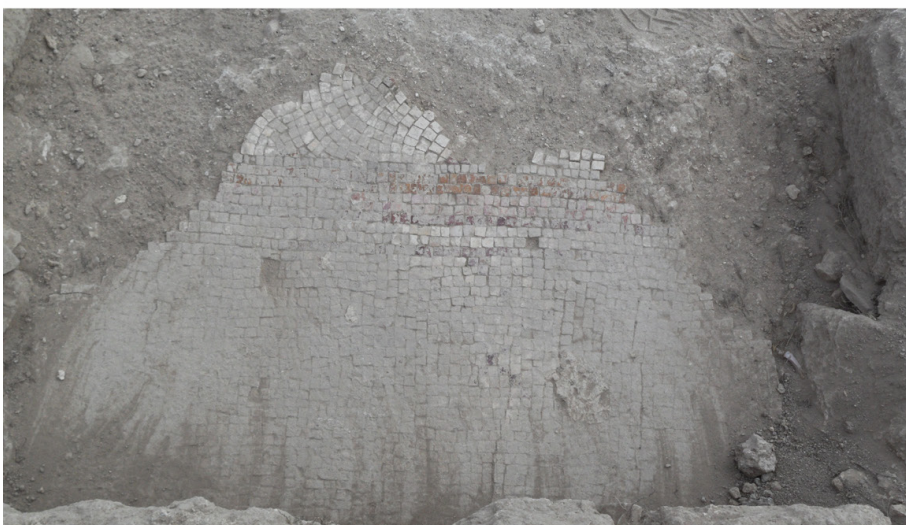
Pl. 3: 2 – Part of a mosaic floor in the central nave adjacent to Wall 5 to the south (by Taher al-Gonmeen)

The nave was paved with a layer of plaster that served as a bedding for a mosaic floor, remnants of which are still visible in several areas adjacent to Walls 1 and 5 (Pl. 3: 2). Additionally, numerous polychrome tesserae were recovered from this locus, further indicating the presence of decorative mosaic flooring.

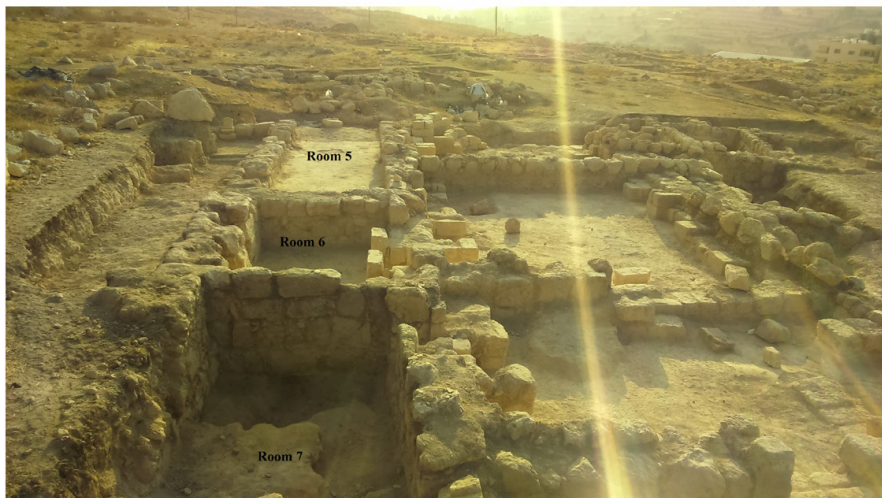
Pl. 4: 1 – General view of the chapel of Yājūz showing the narthex, central nave, northern chambers and southern dwellings, looking east (by Taher al-Gonmeen)

The interior of the chapel was originally accessible via multiple entryways leading to the service rooms within the northern annex. The narthex provided access to Room 7 through a doorway measuring 0.85 m in width, centrally located in Wall 3. A stone threshold, composed of quarried limestone blocks, was installed at the door sill. Room 7 measures 4.25 m in length and 2.60 m in width, with walls preserved to a height of 1.80 m. The floor level of this room is uneven and differs from that of adjacent rooms, as it consists of natural bedrock. Evidence of burning is apparent in the centre of the room, with ashes covering the damaged mosaic floor. The majority of pottery sherds recovered from this context date to the Umayyad period. Notably, Rooms 7 and 6 are not interconnected internally, as no doorway was opened in the common wall designated Wall 10 (Pl. 4: 1).

Room 5 is a large rectangular chamber, measuring 12.30 m in length from Wall 9 to the terminus of Wall 1 and 2.70 m in width from Wall 1 to Wall 11 (see Pl. 4: 1). The floor level of Room 5 is elevated approximately 0.53 m above

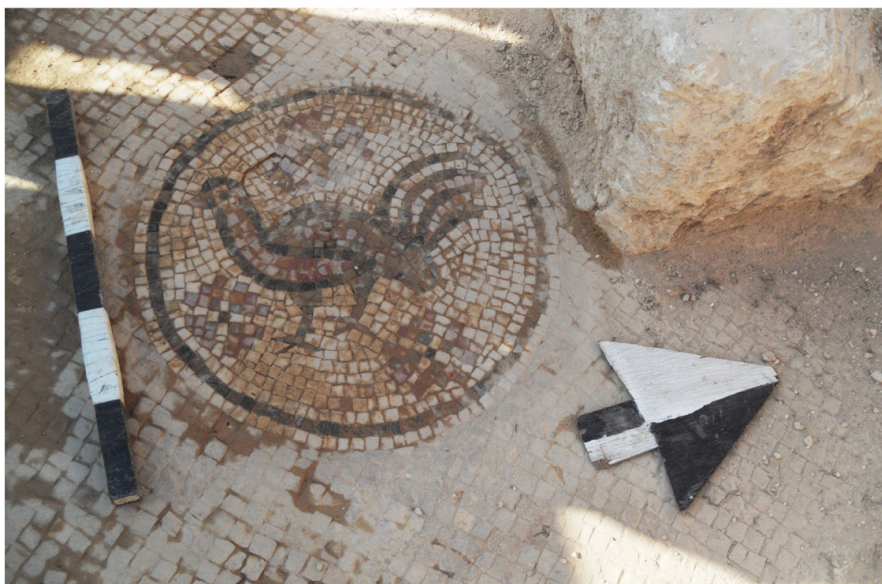
Pl. 4: 2 – Patch of a mosaic floor in Room 6 depicting a bird in a circular frame (by Taher al-Gonmeen)

The mosaic motif depicting a bird in Room 6 closely corresponds – albeit with slight stylistic variations – to decorative elements identified in contemporary chapels and basilicas throughout Jordan. Noteworthy parallels include the Church of Bishop Genesius in Jerash, dated to the sixth century CE (Hamarneh and Mjalli 2009, 29, Fig. 7), as well as the ecclesiastical complex at Ya'mūn, located approximately 25 km south of Irbid (El-Najjar *et al.* 2001, 413-416; Figs. 3-5).

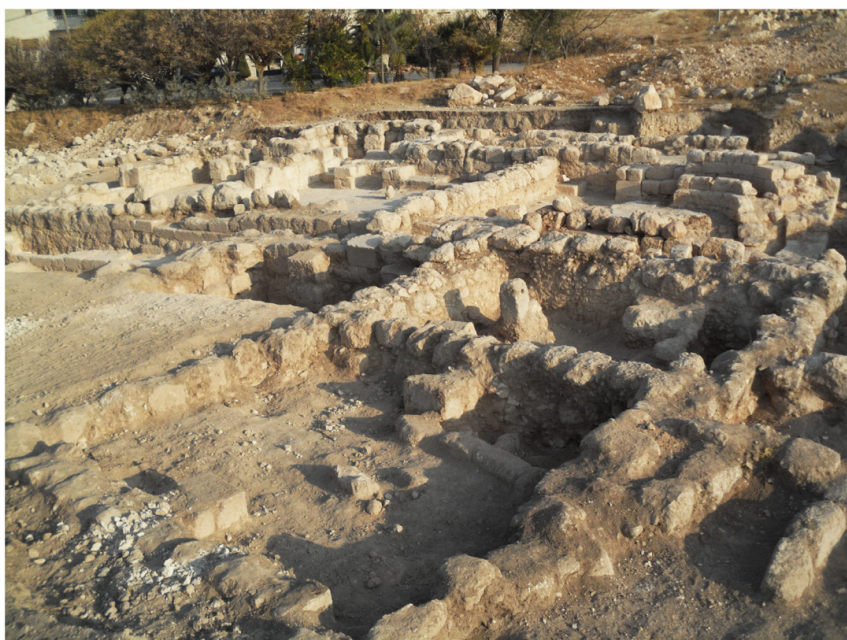
PLATE 5

Pl. 5 – The southern private rooms, looking northwest (by Taher al-Gonmeen)

To the south of the church, a minimum of four rooms (Rooms 1-4) have been excavated (Pl. 5). Their domestic function is inferred from the assemblages of everyday artefacts recovered from various loci inside the rooms, as well as from their planimetric configuration and architectural installations. Similar to the church, only the substructures of these dwellings remain preserved. The material culture uncovered within these rooms comprises a mixture of Byzantine and Umayyad-period artefacts, including grinding tools, pottery vessels such as juglets, candle holders, oil lamps, cooking pots, bronze coins, copper objects and limestone sculptures.
